Titanic, The Anatomy of a Disaster

A Report from the Marine Forensic Panel (SD-7)

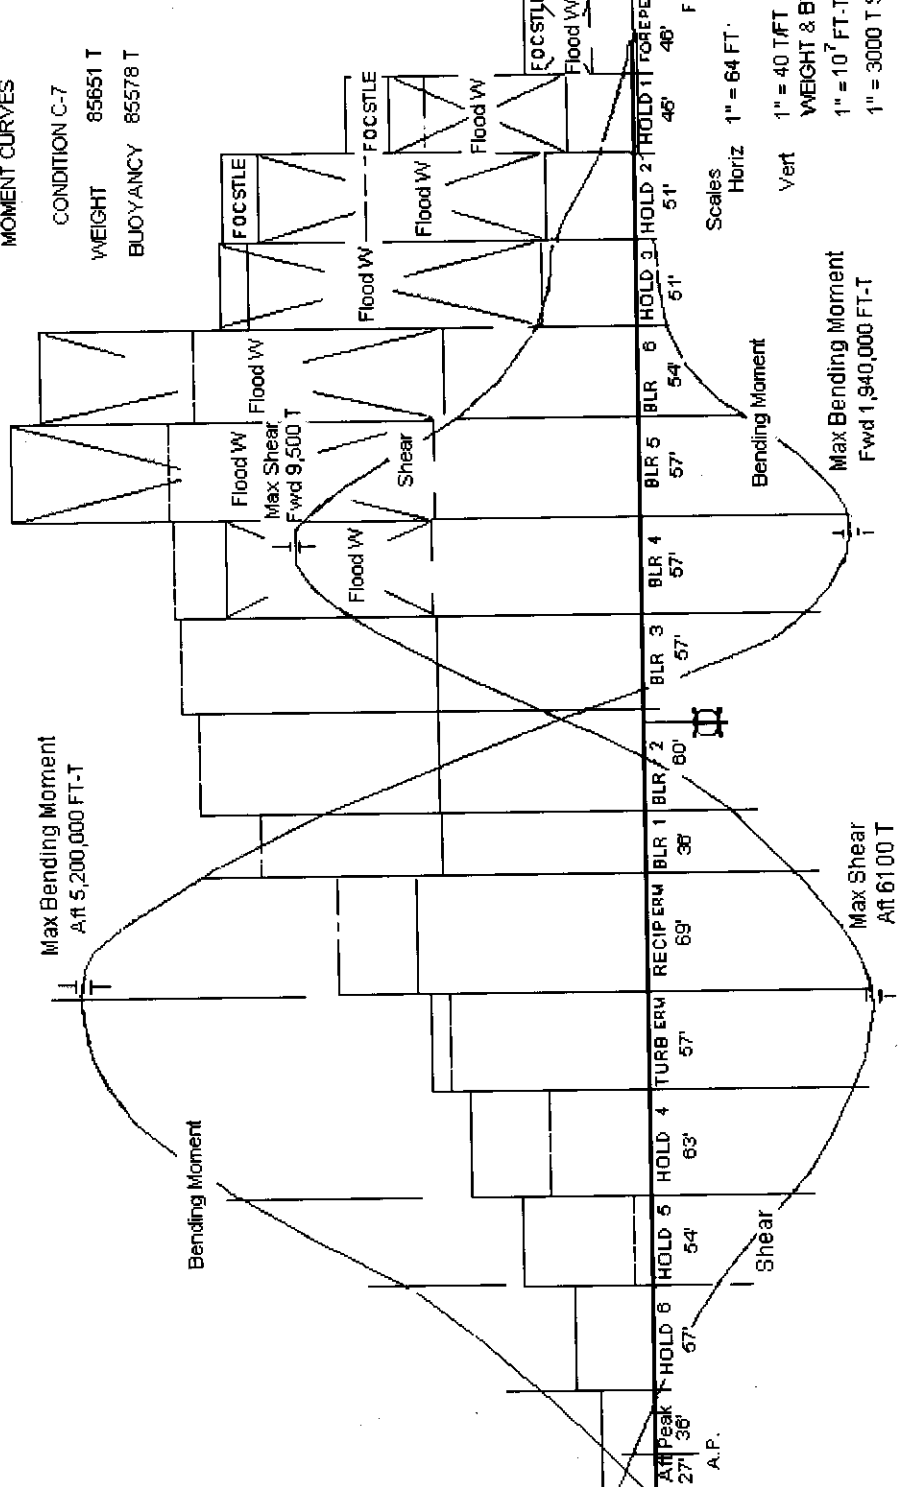
The flooding diagrams of Conditions C-6 and C-7 from Reference [5].

CONDITION C-7	
WEIGHT	85651 T
BUOYANCY	85578 T
